FLIGHT MEASUREMENTS OF LATERAL AND DIRECTIONAL  
STABILITY AND CONTROL CHARACTERISTICS  
OF THE GRUMMAN F8F-1 AIRPLANE

TED NO. NACA 2379

H. L. Crane and J. P. Reeder

Langley Memorial Aeronautical Laboratory  
Langley Field, Va.

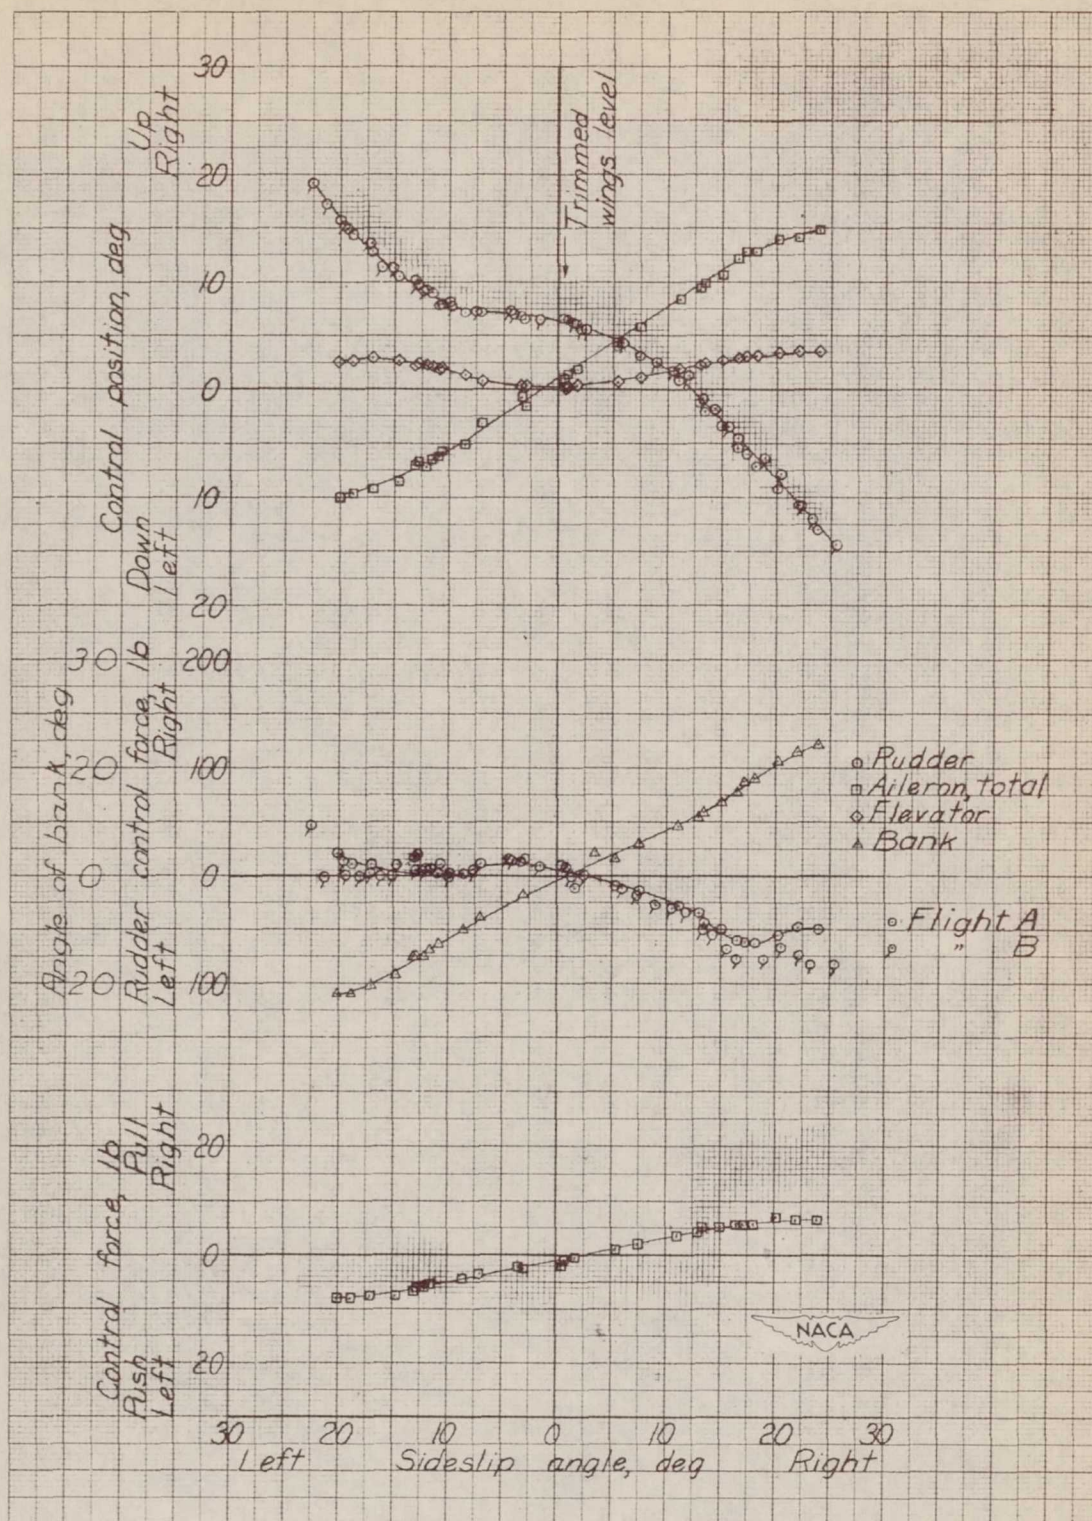
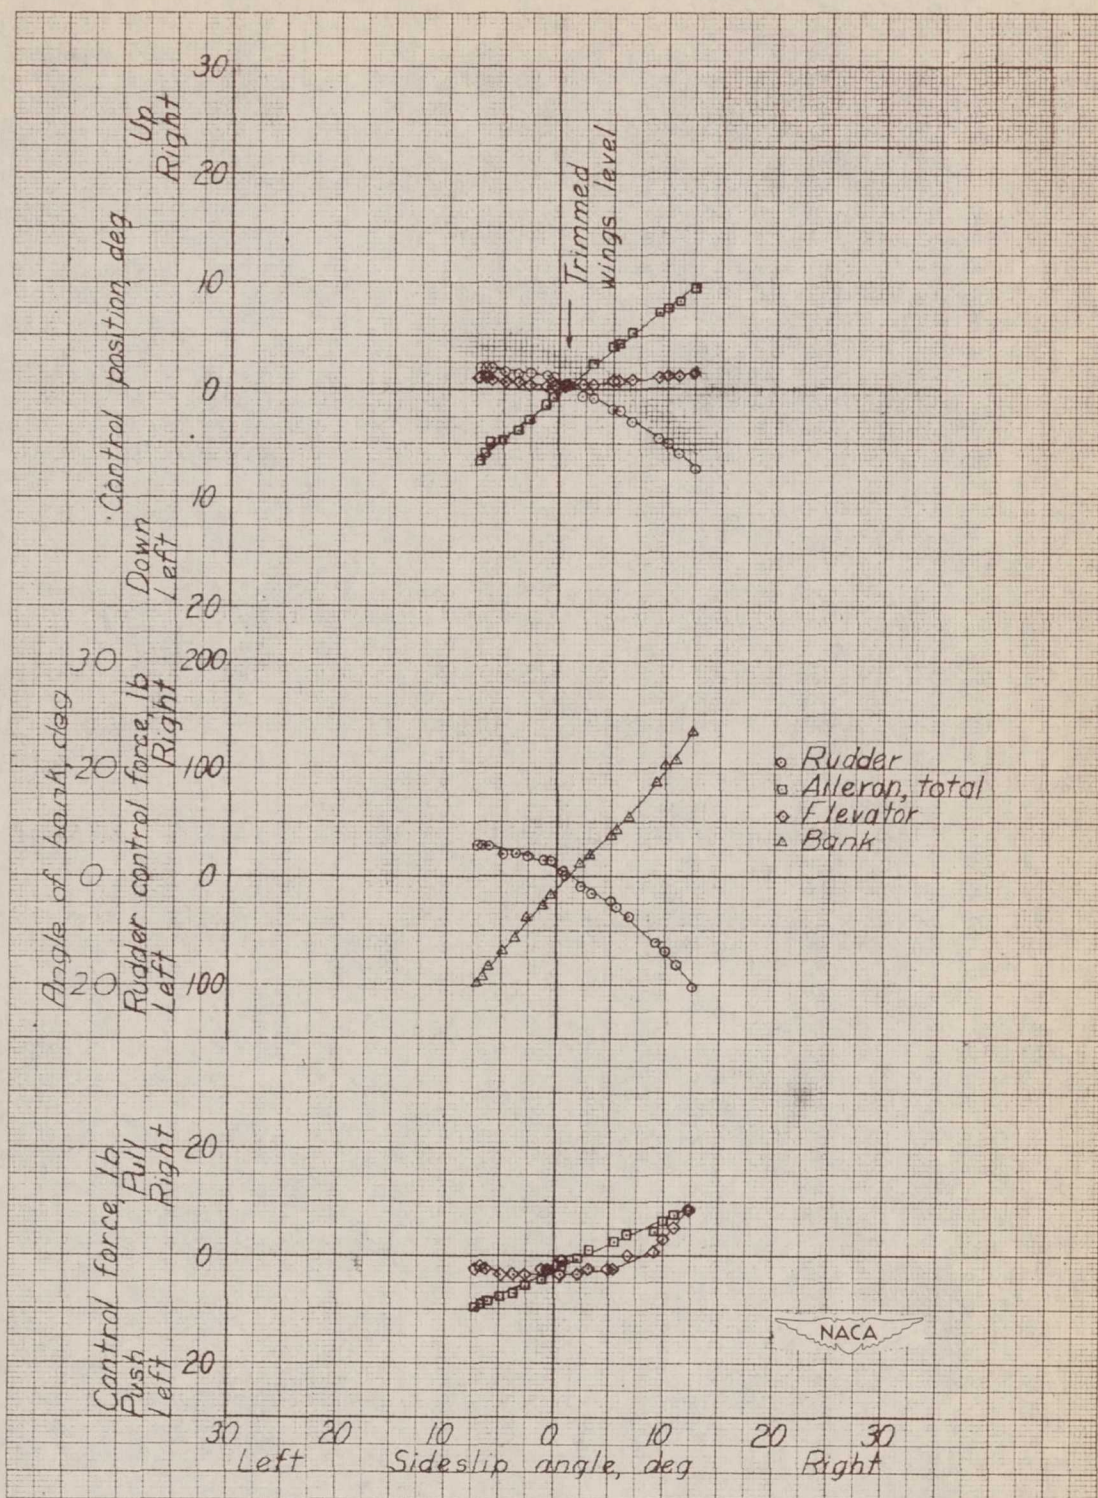
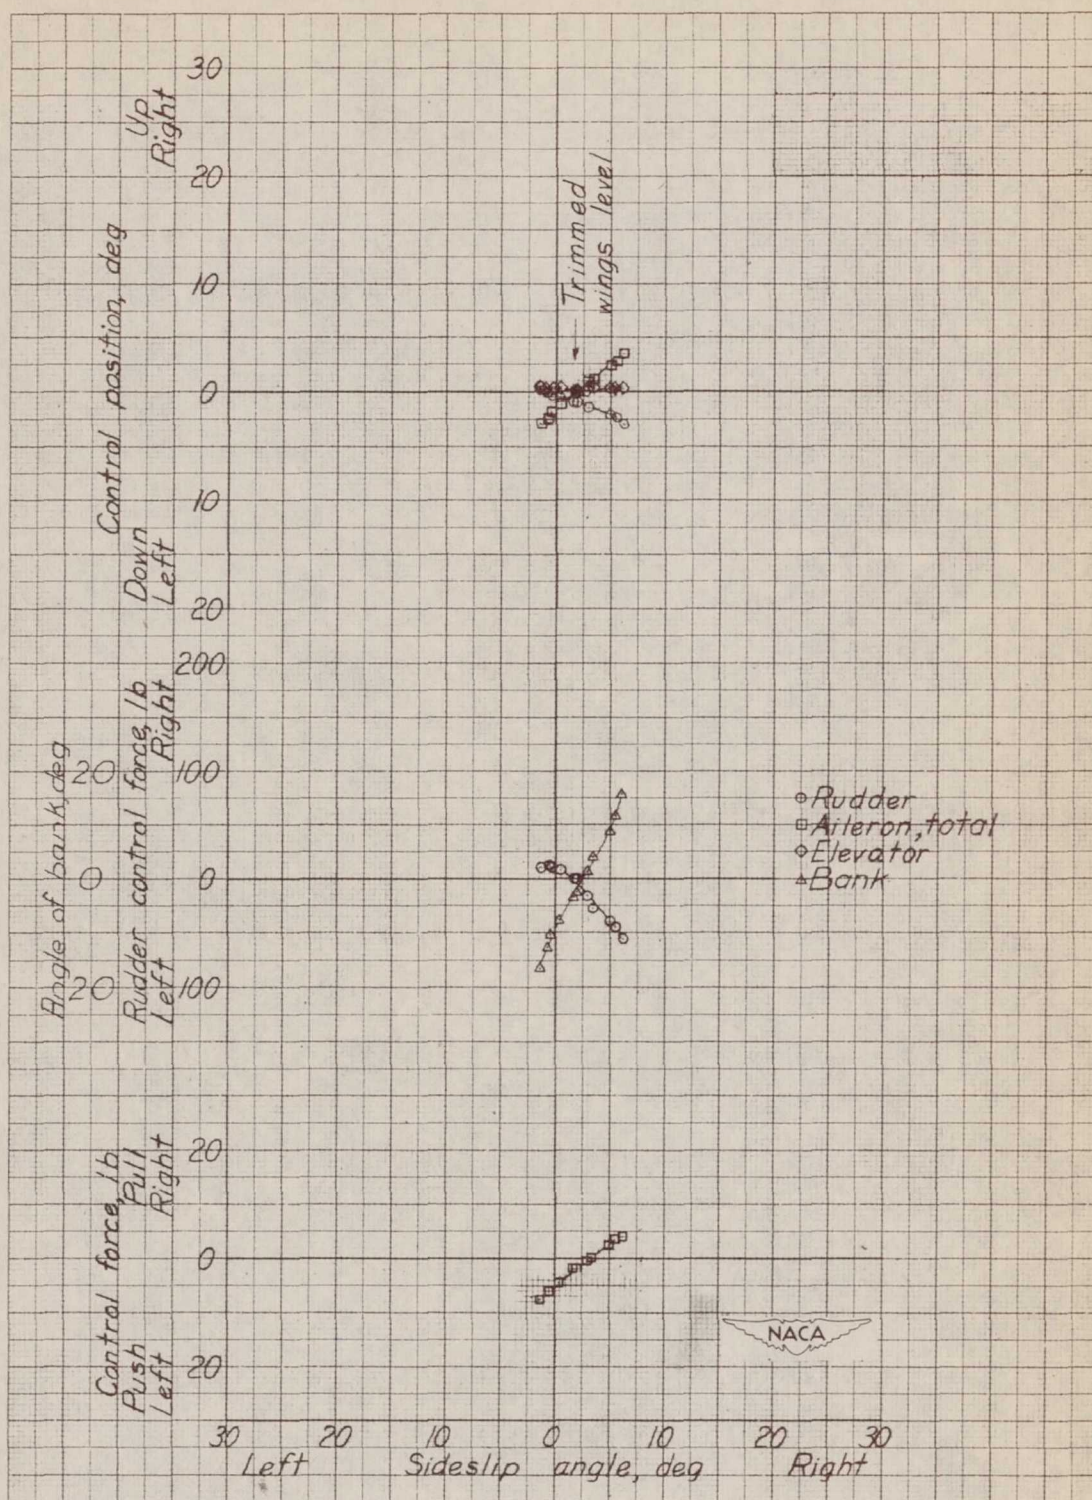
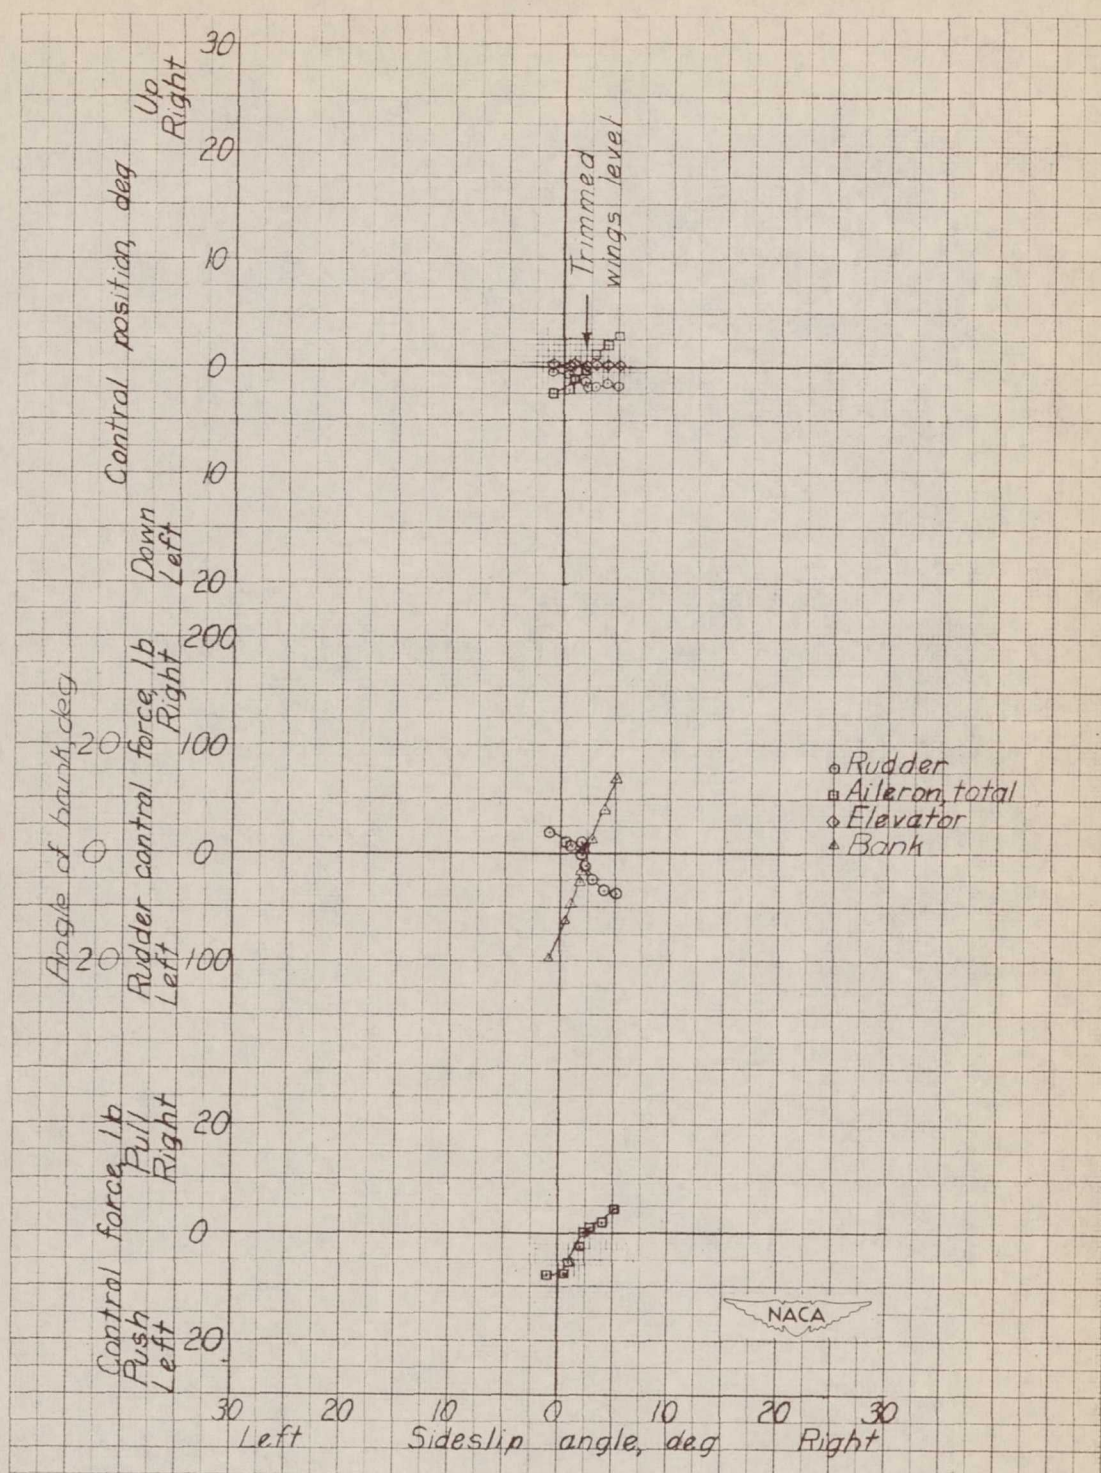
(a) 150 miles per hour, rudder tab  $14.0^\circ$  left, oil cooler open.

Figure 16.- Sideslips in the rated-power, clean condition (41 in. Hg, 2600 rpm) at 5000 feet with belly tank on, cowl closed, canopy closed, F8F-1 airplane with tail configuration 1.

(b) 245 miles per hour, rudder tab  $1.3^\circ$  left, oil cooler closed.

(c) 345 miles per hour, rudder tab  $0.3^\circ$  right, oil cooler closed.

(d) 395 miles per hour, rudder tab  $1.7^\circ$  right, oil cooler closed.

Addition of the belly tank reduced the directional stability in all conditions so that the value of  $d\delta_r/d\beta$  in the rated-power, clean condition increased from 0.10 at small angles of left sideslip at 150 miles per hour to about 0.35 at 350 miles per hour and decreased to 0.25 at 395 miles per hour. The rudder-free directional stability was neutral in left sideslips up to  $20^\circ$  at 150 miles per hour. At higher speeds the variation of rudder force with sideslip angle was small in comparison with that of other fighter-type airplanes previously tested. For example, the sideslip obtained per pound of pedal force was almost three times that obtained with the F6F-3 airplane at 300 miles per hour.

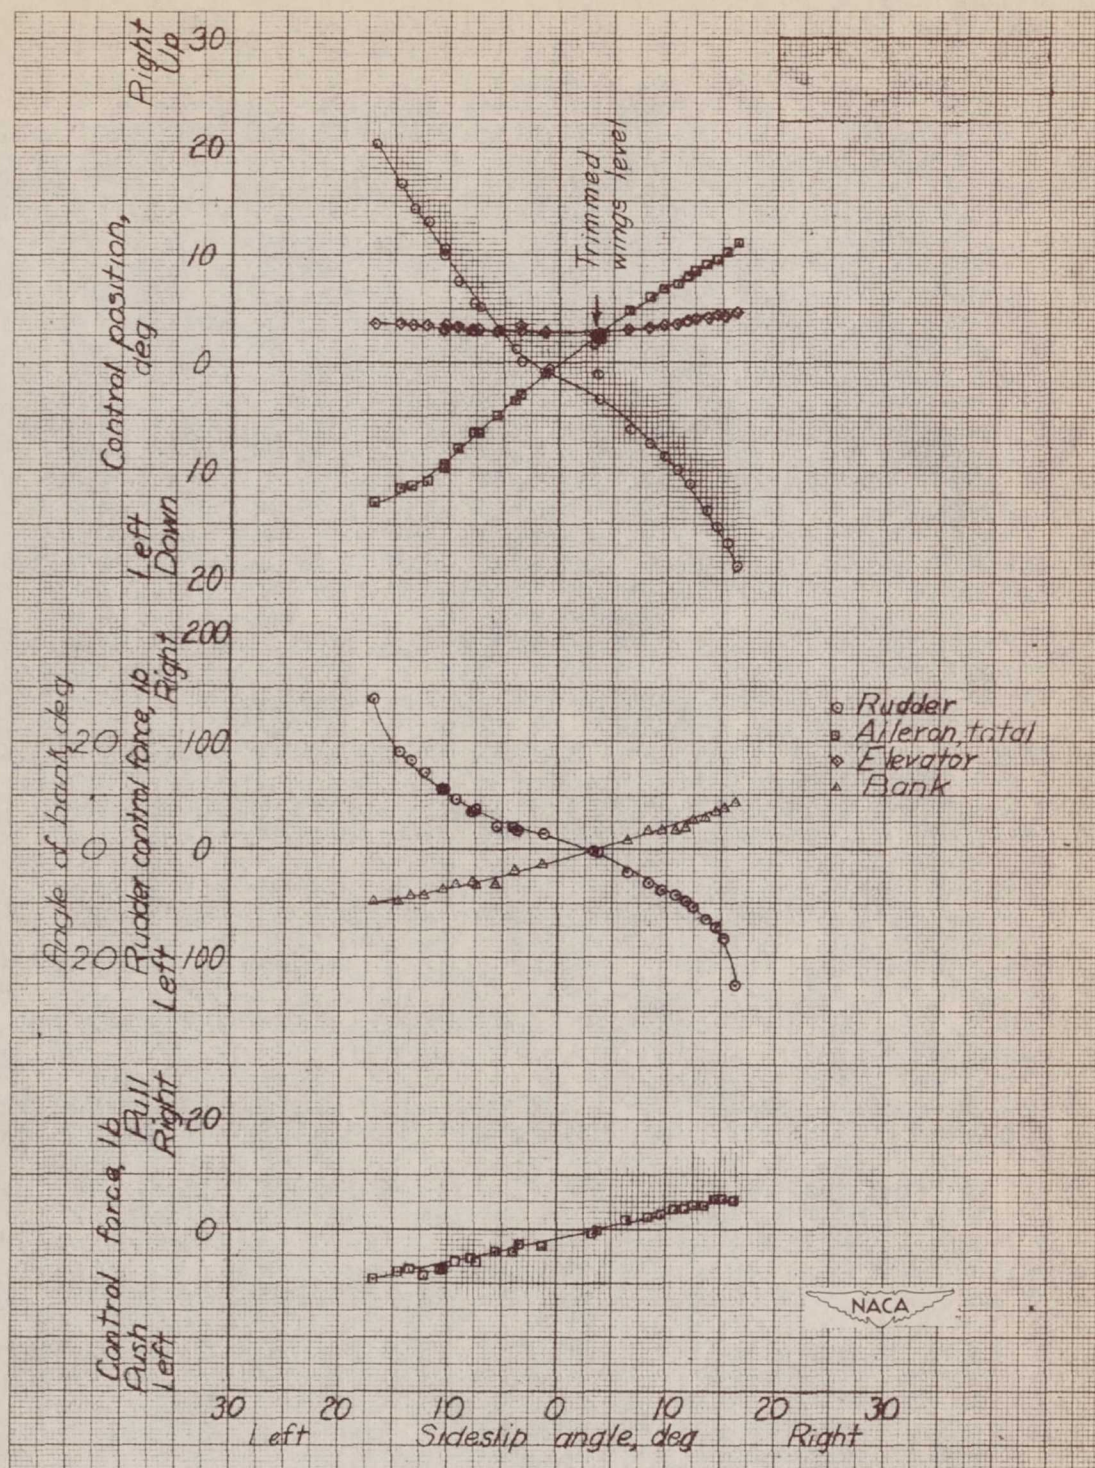
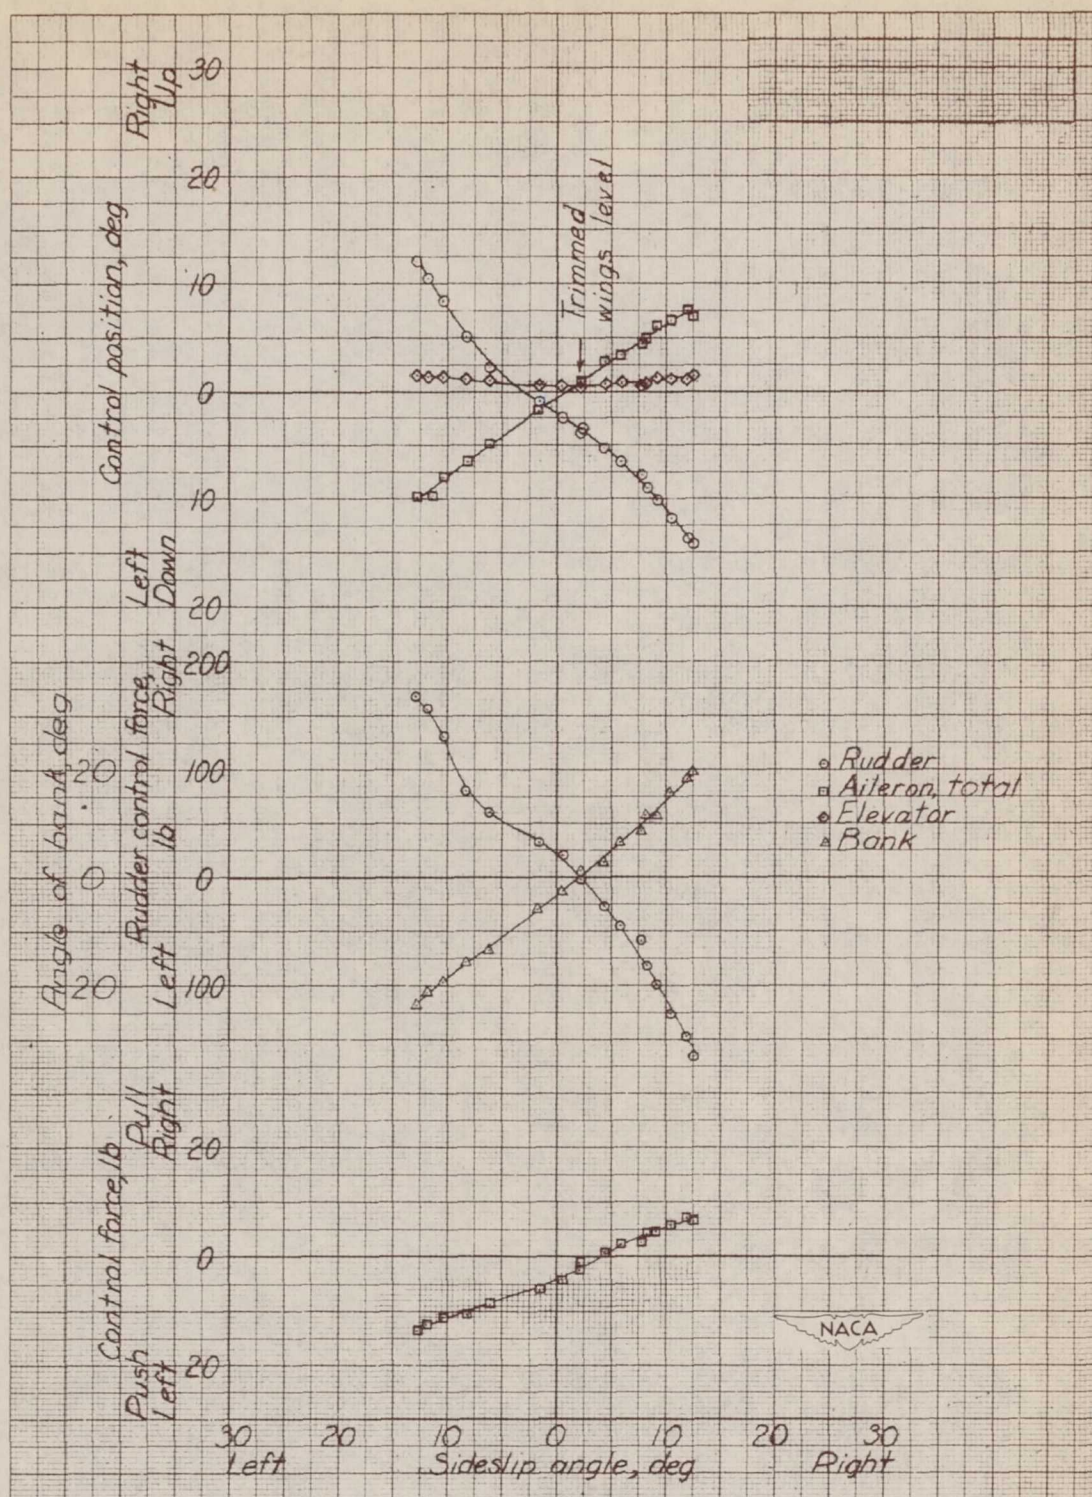
(a) 150 miles per hour, rudder tab  $5.7^\circ$  right.

Figure 17.- Sideslips in the clean, engine-idling condition at 5000 feet with belly tank off, cowl closed, oil cooler closed, canopy closed, F8F-1 airplane with tail configuration 1.

(b) 245 miles per hour, rudder tab  $5.7^\circ$  right.

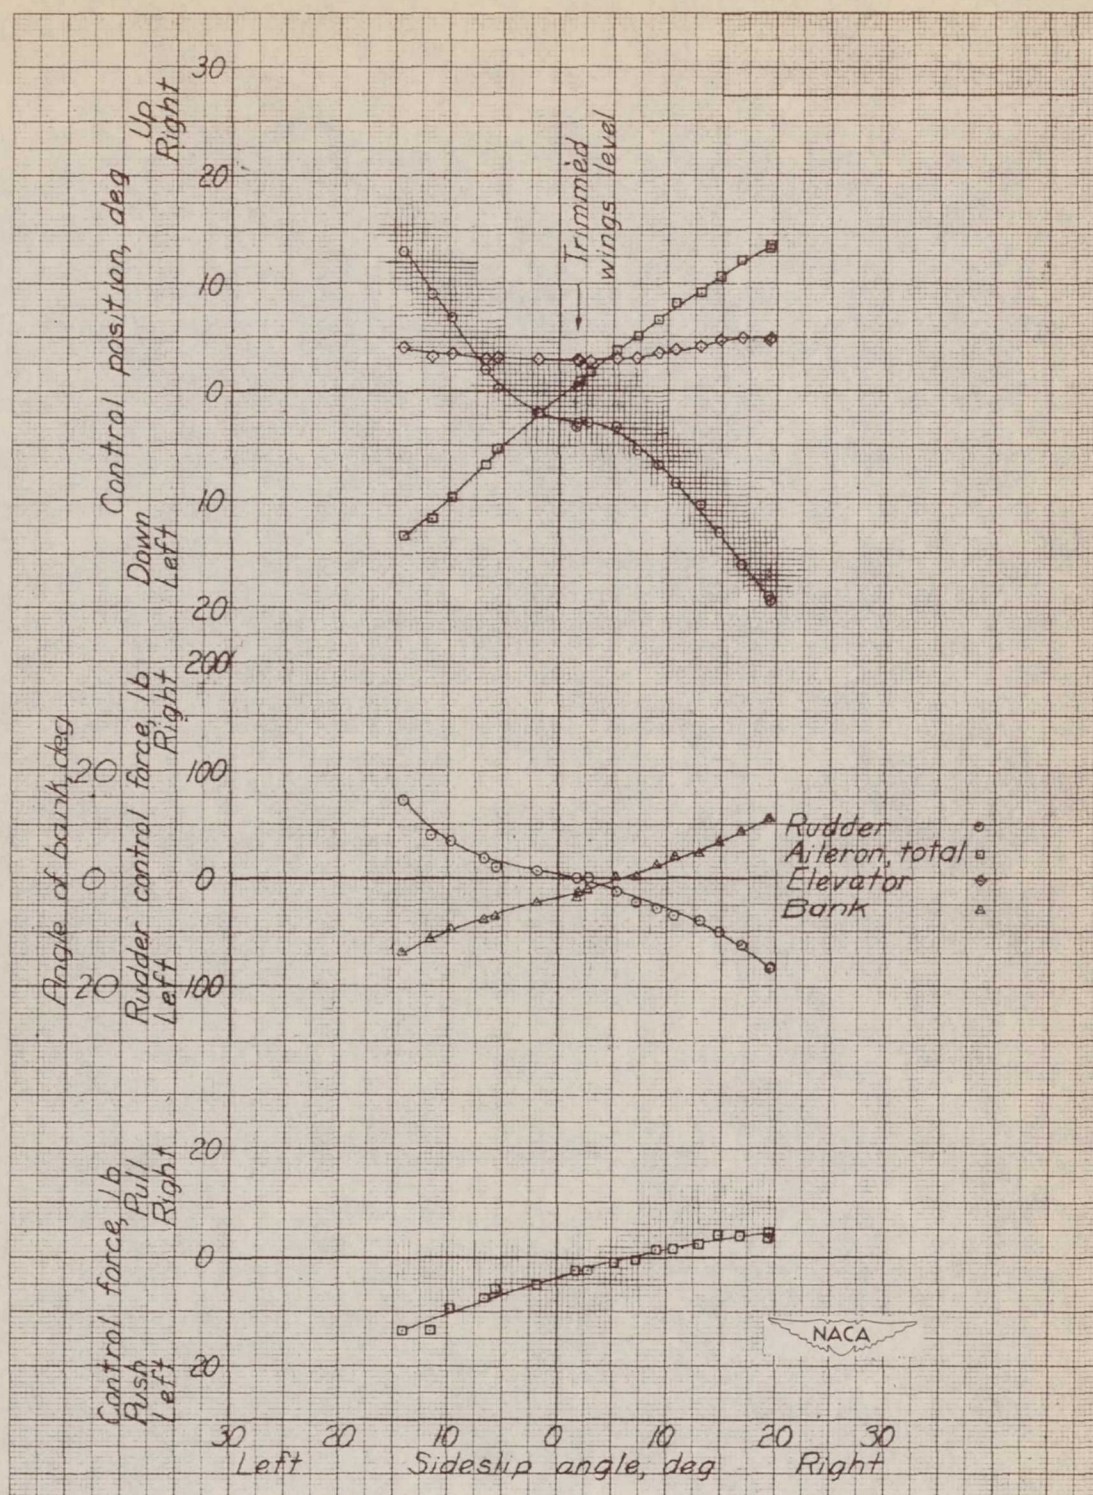
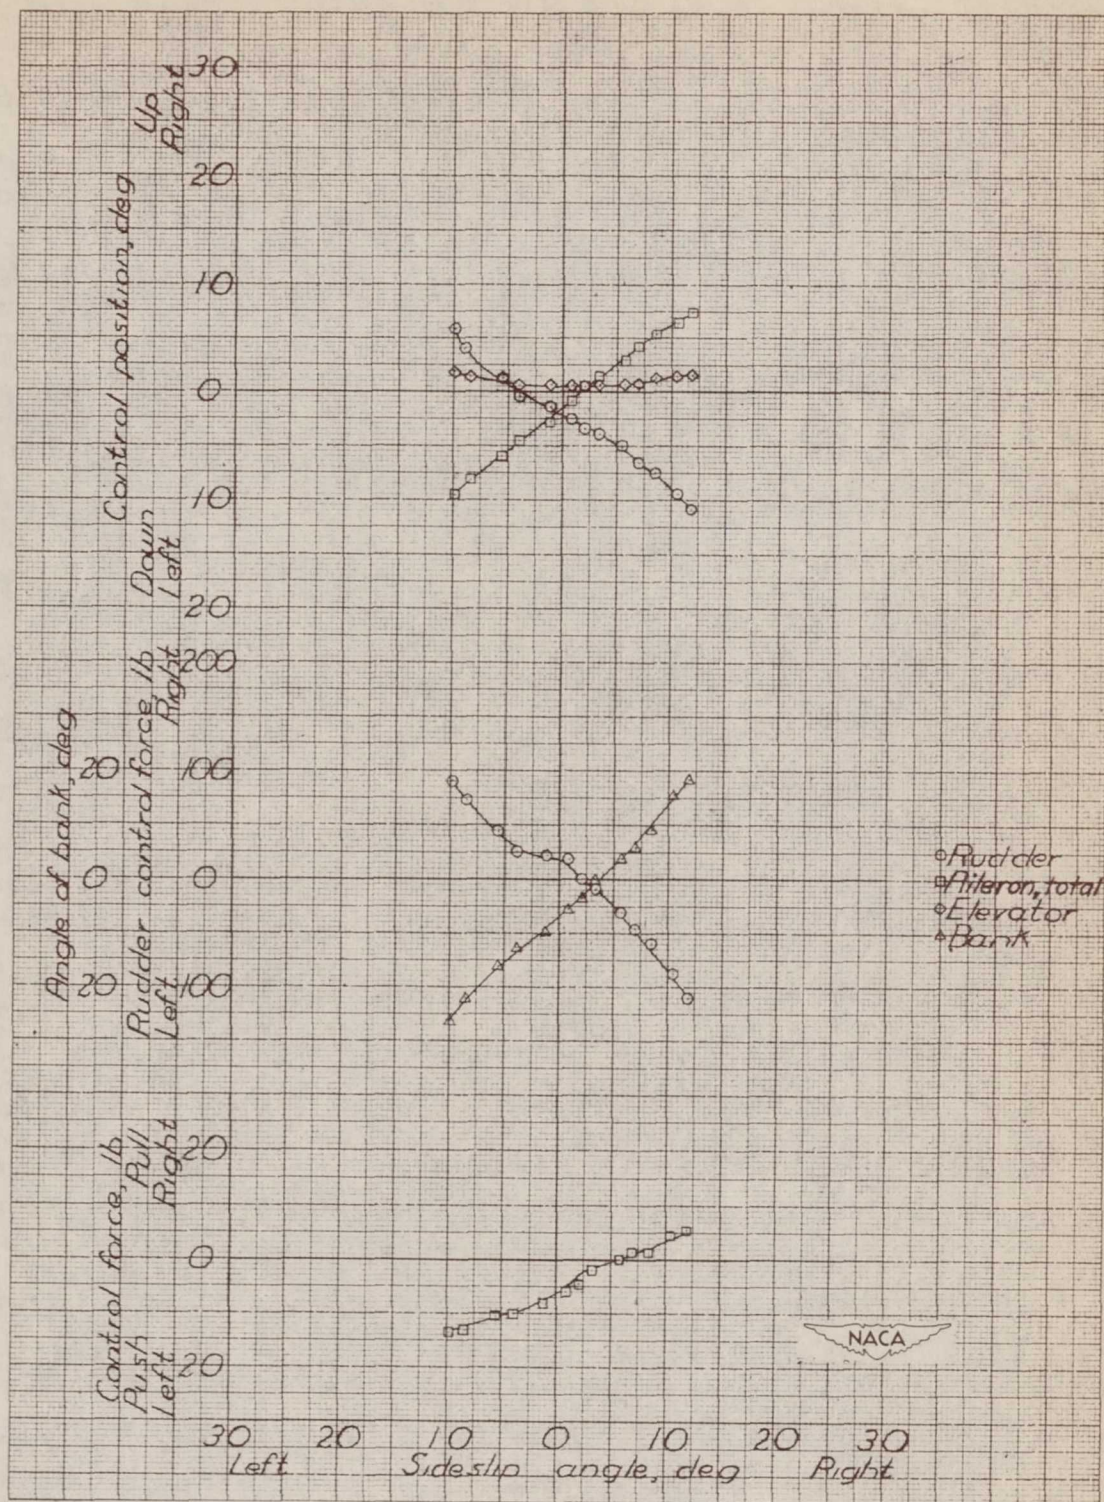
(a) 150 miles per hour, rudder tab  $5.7^\circ$  right.

Figure 18.- Sideslips in the clean, engine-idling condition at 5000 feet with belly tank on, cowl closed, oil cooler closed, canopy closed, F8F-1 airplane with tail configuration 1.

(b) 245 miles per hour, rudder tab  $6.3^\circ$  right.

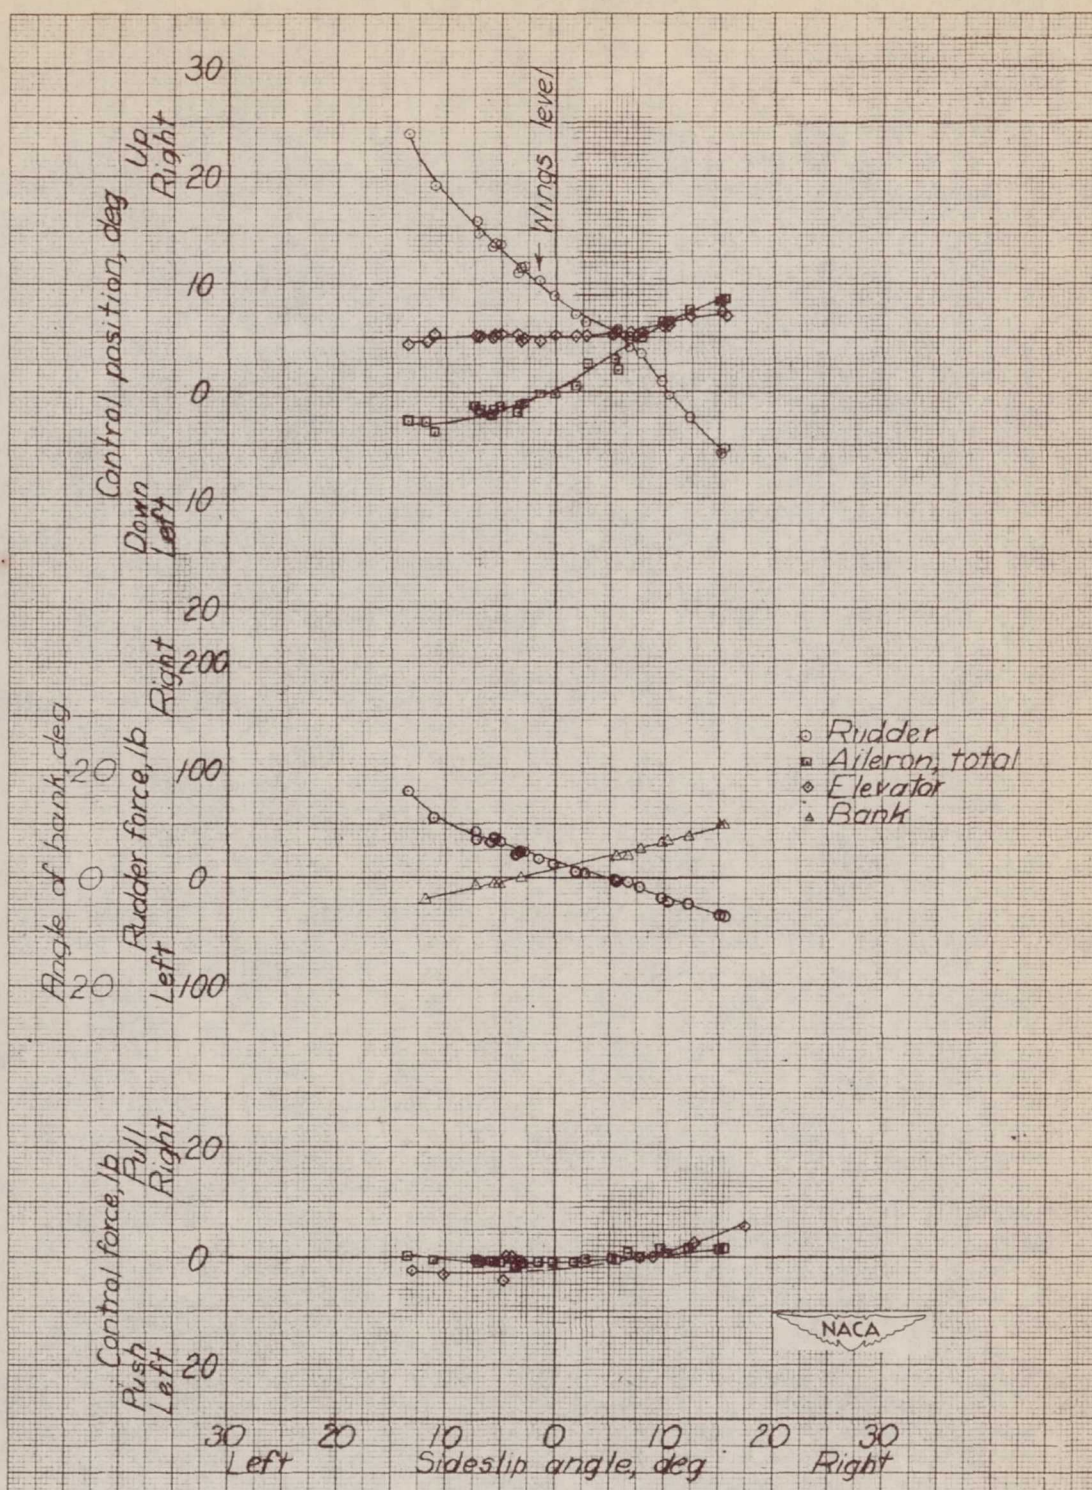
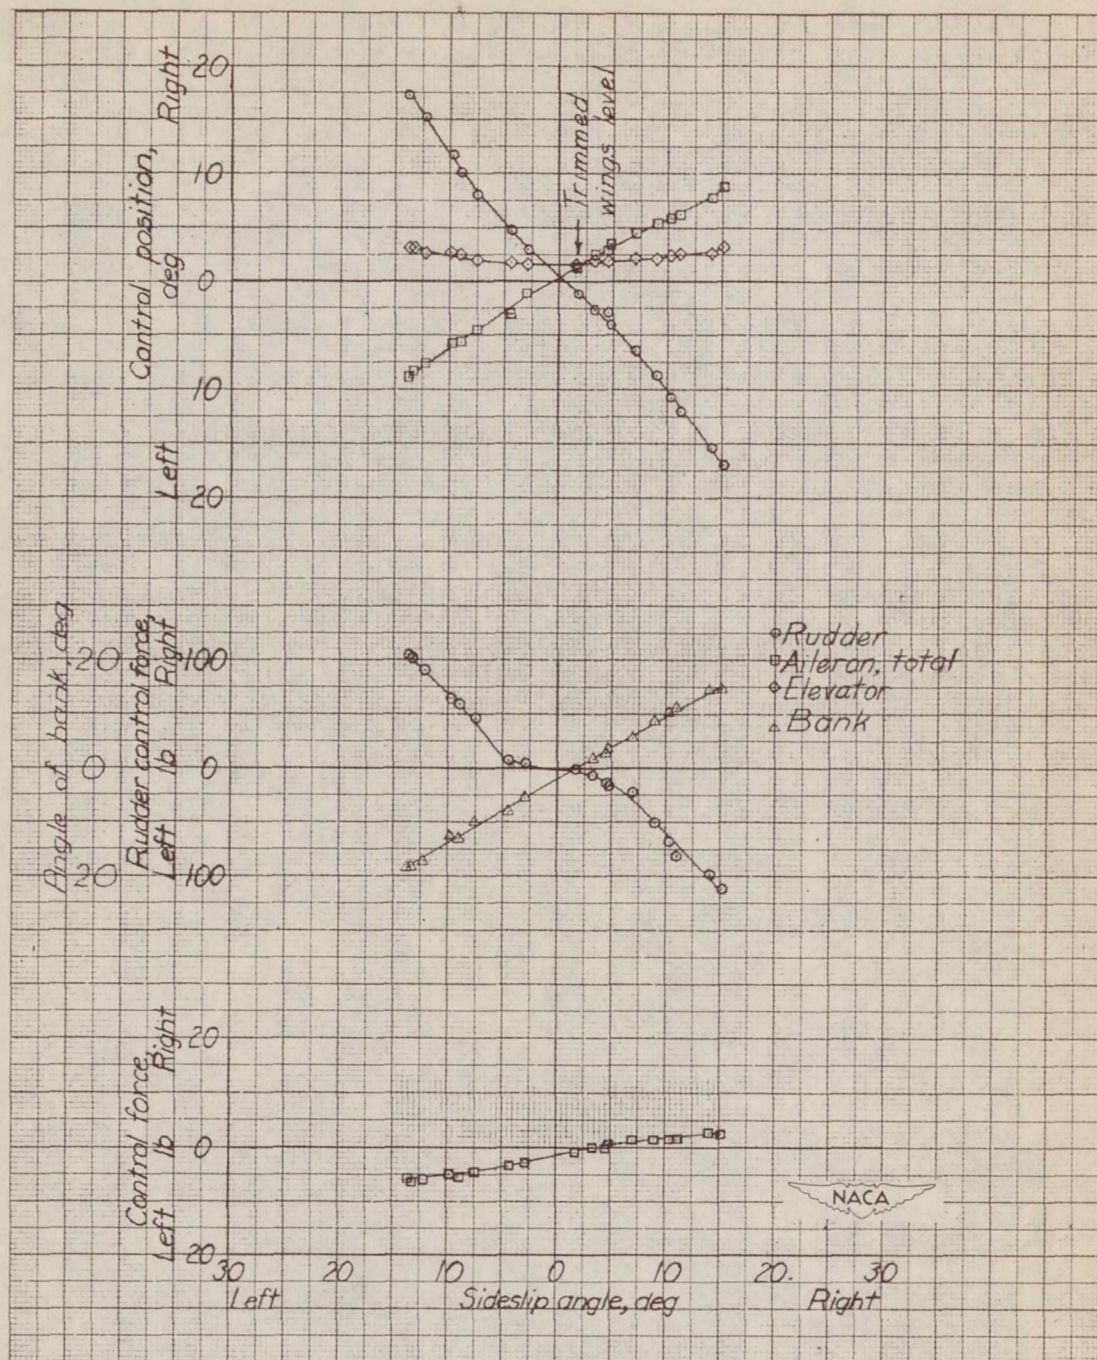
(a) 90 miles per hour, rudder tab  $17.5^\circ$  left (full tab).

Figure 19.- Sideslips in the power-approach condition (20 in. Hg at 2300 rpm) flaps and landing gear down at 5000 feet with belly tank off, cowl closed, oil cooler closed, canopy open, F8F-1 airplane with tail configuration 1.

(b) 150 miles per hour, rudder tab  $0.8^\circ$  right.

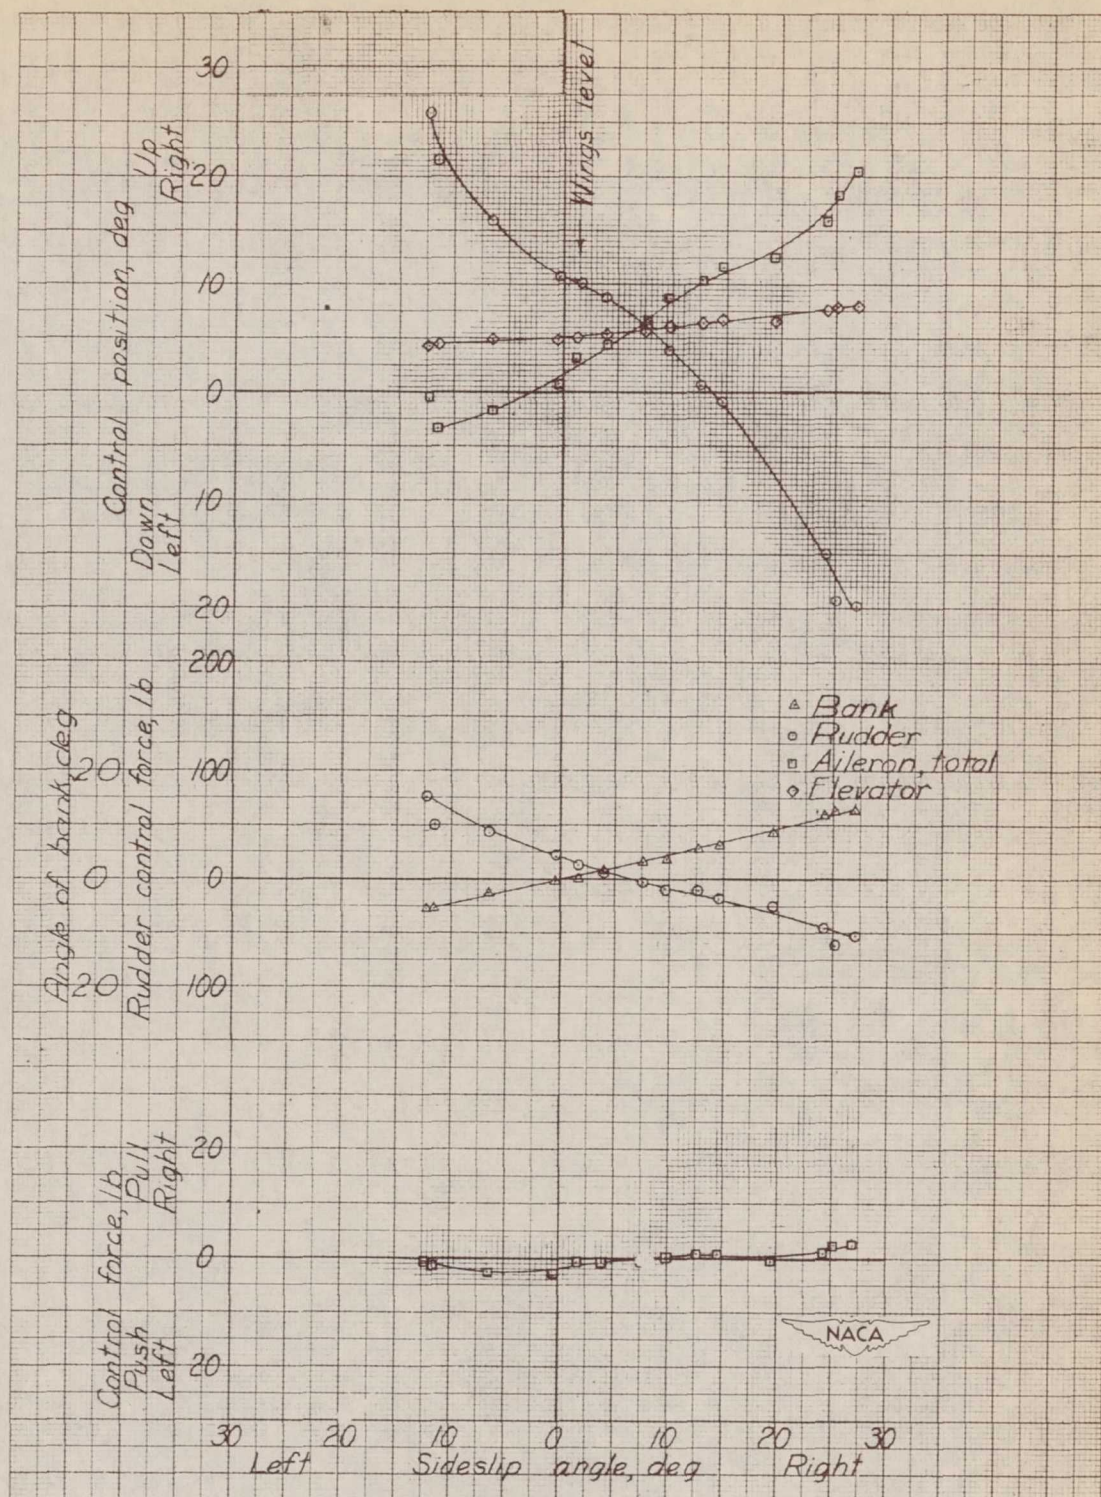
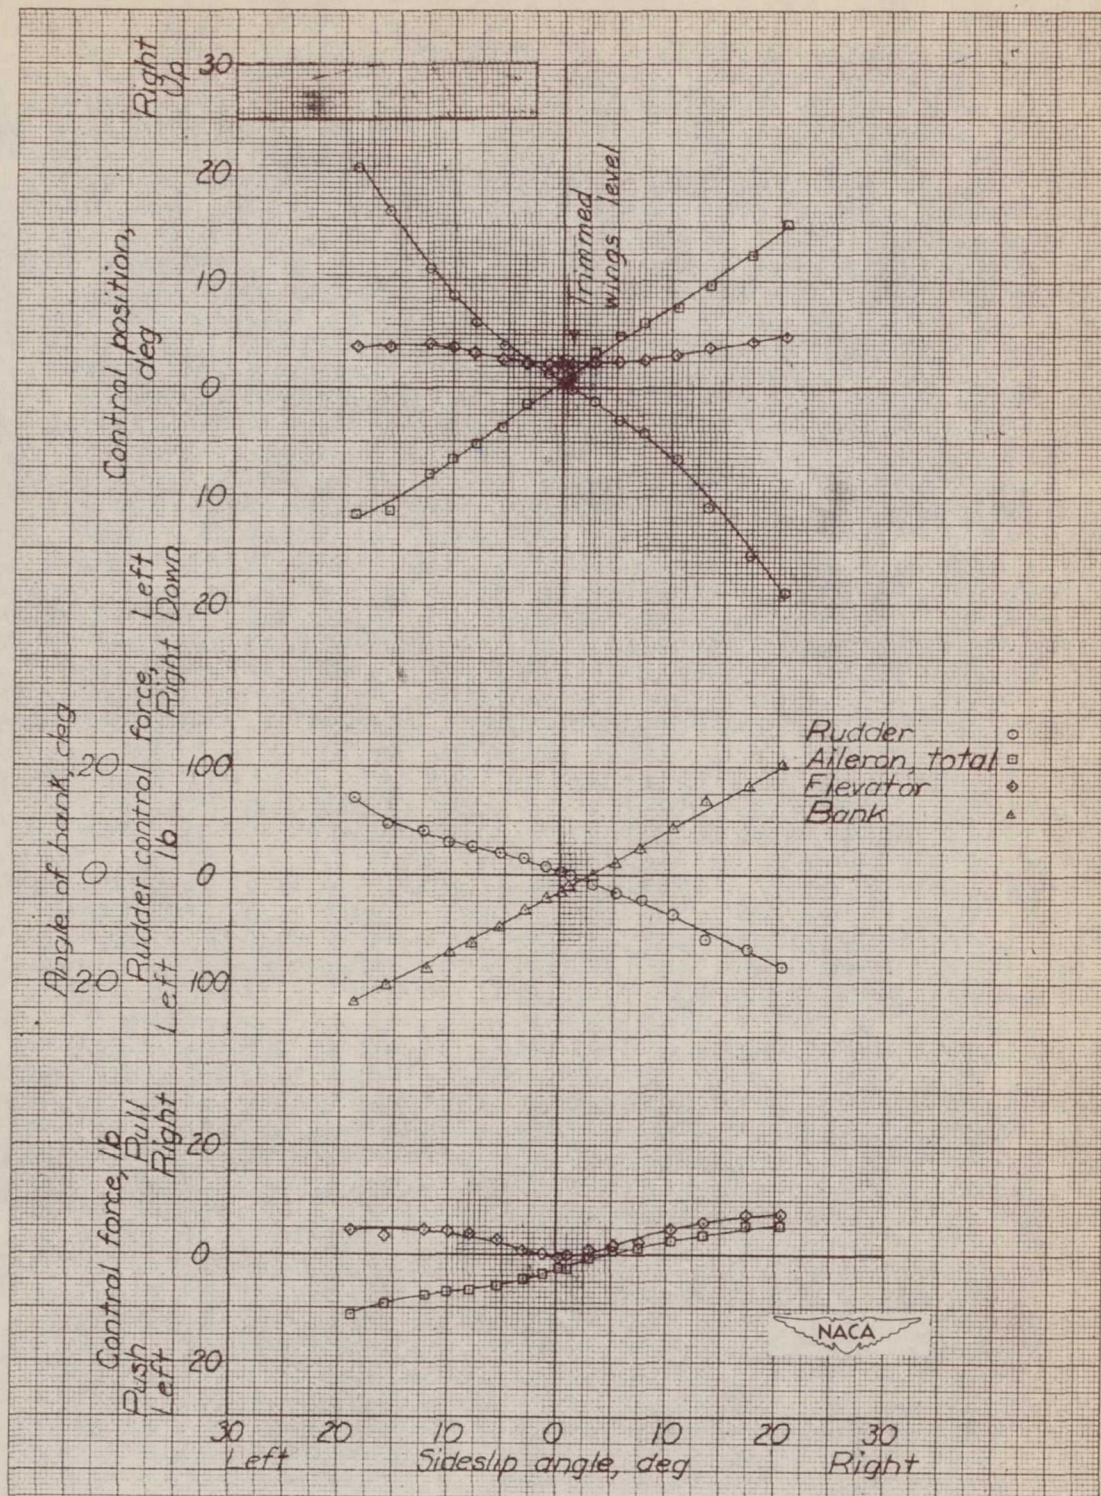
(a) 90 miles per hour, rudder tab  $17.5^\circ$  left (full tab).

Figure 20.- Sideslips in the power-approach condition (20 in. Hg at 2300 rpm) with flaps and landing gear down at 5000 feet, with belly tank on, cowl closed, oil cooler closed, canopy open, F8F-1 airplane, with tail configuration 1.

(b) 150 miles per hour, rudder tab  $2.3^\circ$  left.
